# IR THERMOGRAPHIC INSPECTION DIGITAL REALTY TRUST DATACENTER

<b>DIGITAL REALTY TRUST</b>  <b>Digital Realty Trust Singapore</b> 29A International Business Park	Site Address:	XXX Data Center
	Date of Inspection:	XXX June 2011
	Inspection Commissioned By:

## APPENDIX A – Scanning Reports

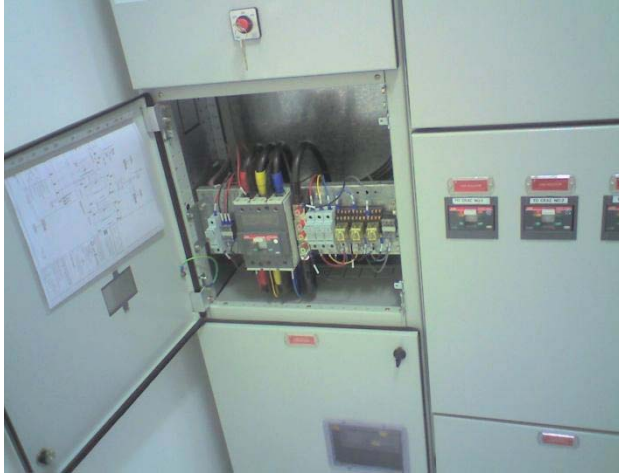
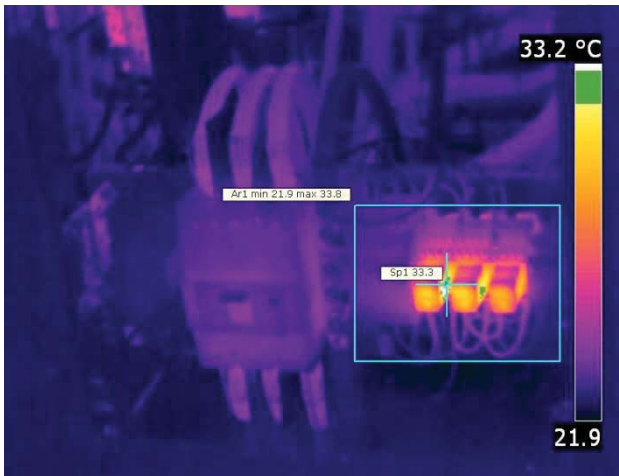
### Photo & Identification – CRAC Distribution Board

Location	(Level 4, CRAC Room)
Equipment	CRAC DB
Nom load	100%
Actual load	75%
Rating	( Medium )
Recommendation	Monitor
Atmospheric Temperature	22.0°C
Area1 Min. Temperature	21.9°C
Area1 Max Temperature	33.8°C
Spot 1 Temperature	33.3°C

During 75% load, the above thermal scan picture indicates that the relays temperature (33.8°C max) are higher than the ambience temperature but it is within the acceptable range of working condition as electromagnet component does generate heat during operation.

Action: To monitor the temperature.

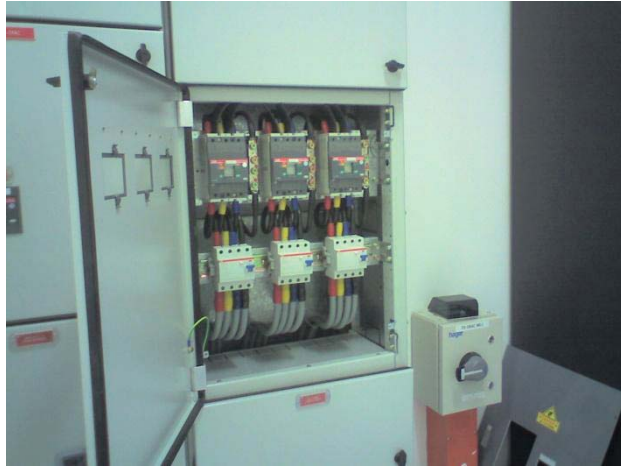
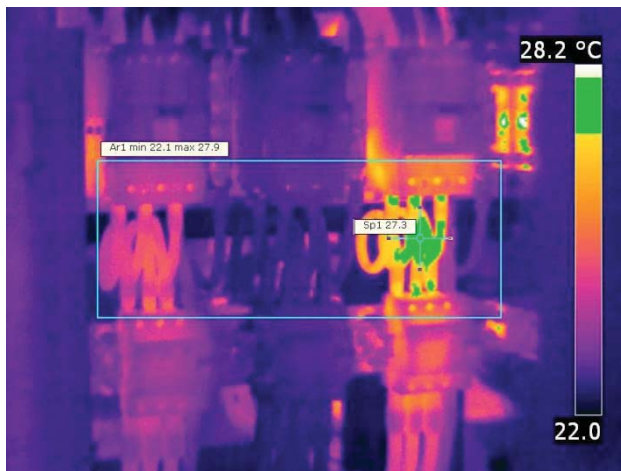
**Photo & Identification – CRAC Distribution Board**

Location	(Level 4, CRAC Room)
Equipment	CRAC DB
Nom load	100%
Actual load	75%
Rating	(Low)
Recommendation	Monitor
Atmospheric Temperature	22.0°C
Area1 Min. Temperature	22.1°C
Area1 Max Temperature	27.9°C
Spot 1 Temperature	27.3°C

During 75% load, the above thermal scan picture indicates higher temperature (27.3°C) on CRAC 3 breaker than the surrounding, is due to the CRAC is in operation mode. The temperature shown is within the acceptable range.

Action: To monitor the temperature.

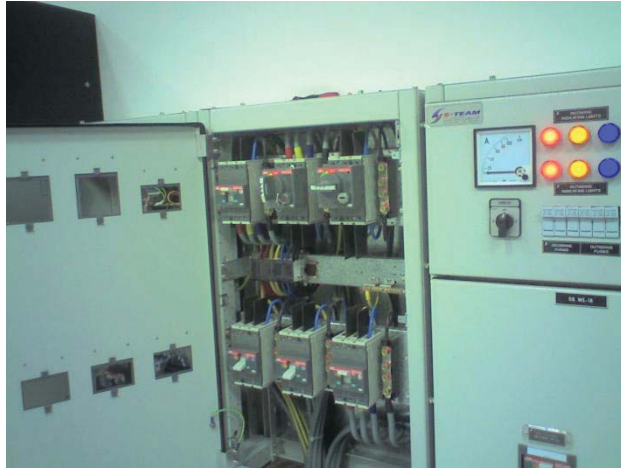
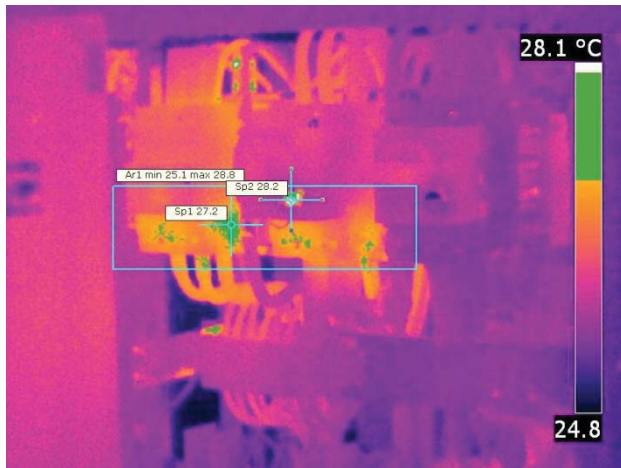
**Photo & Identification – UPS Distribution Board**

Location	(Level 4, Equipment Room)
Equipment	UPS DB
Nom load	100%
Actual load	30%
Rating	(Low)
Recommendation	Monitor
Atmospheric Temperature	22.0°C
Area1 Min. Temperature	25.1°C
Area1 Max Temperature	28.8°C
Spot 1 Temperature	27.2°C
Spot 2 Temperature	28.2°C

During 30% load, the above thermal scan picture indicates that the breakers temperature (25.1°C to 28.8°C) are within the acceptable range.

Action: To monitor the temperature.

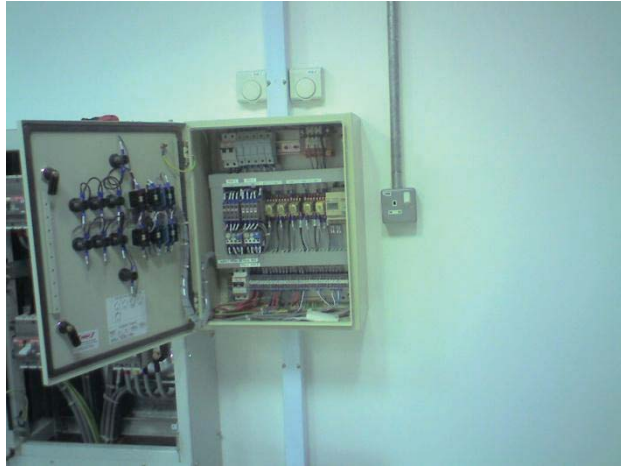
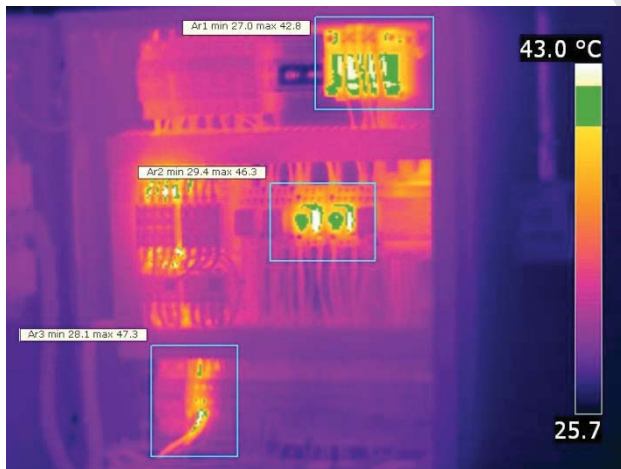
**Photo & Identification – Fan Coil Unit Board**

Location	(Level 4, Equipment Room)
Equipment	FCU Board
Nom load	100%
Actual load	50%
Rating	(Medium)
Recommendation	Monitor
Atmospheric Temperature	22.0°C
Area 1 Min. Temperature	27.0°C
Area 1 Max. Temperature	42.8°C
Area 2 Min. Temperature	29.4°C
Area 2 Max. Temperature	46.3°C
Area 3 Min. Temperature	28.1°C
Area 3 Max. Temperature	47.3°C

During 50% load, the above thermal scan picture indicates 3 hot area. Area 1 – step down transformer which has max temperature of 42.8°C, Area 2 – relays max temperature at 46.3°C, and Area 3 – terminal block max temperature at 47.3°C.

Action: To monitor the temperature of Area 2 and Area 3.

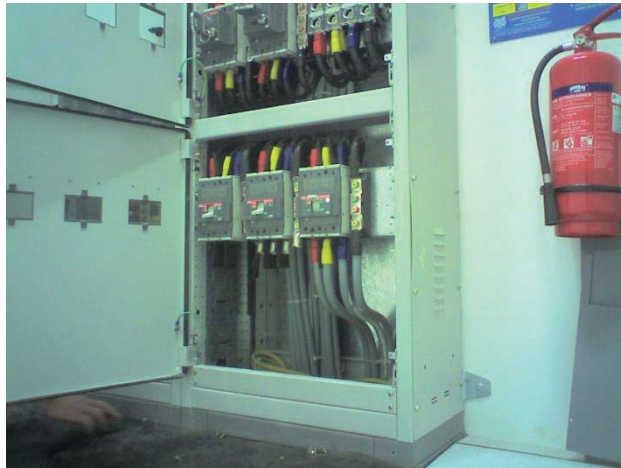
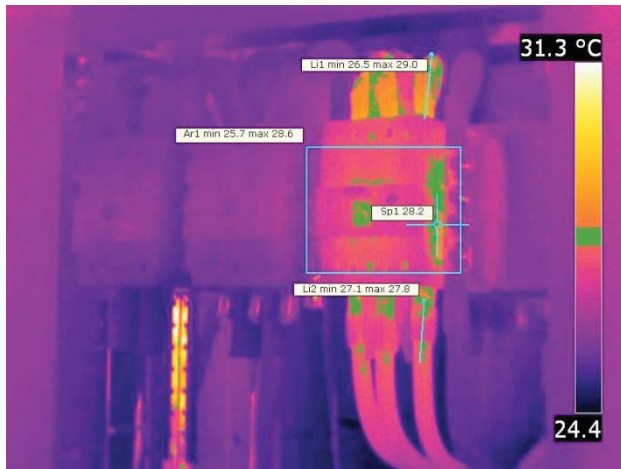
**Photo & Identification – MSB Distribution Board**

Location	(Level 4, Equipment Room)
Equipment	MSB
Nom load	100%
Actual load	75%
Rating	(Low)
Recommendation	Monitor
Atmospheric Temperature	22.0°C
Area1 Min. Temperature	25.7°C
Area1 Max Temperature	29.6°C
Spot 1 Temperature	28.2°C
Line 1 Min. Temperature	26.5°C
Line 1 Max. Temperature	29.0°C
Line 2 Min. Temperature	27.1°C
Line 2 Max. Temperature	27.8°C

During 75% load, the above thermal scan picture indicates that the breakers (CRAC) temperature (25.7°C to 29.6°C) are within the acceptable range.

Action: To monitor the temperature.

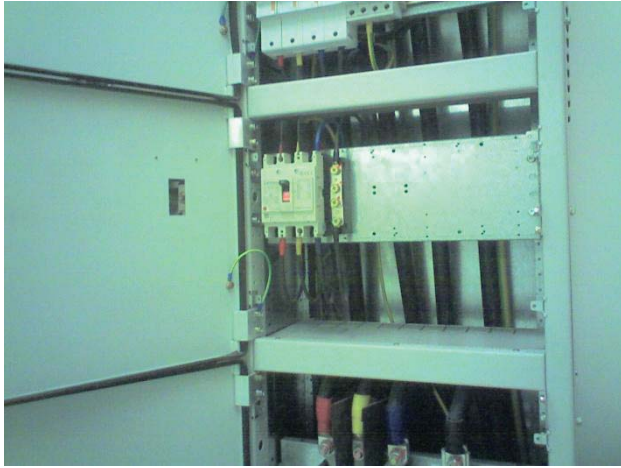
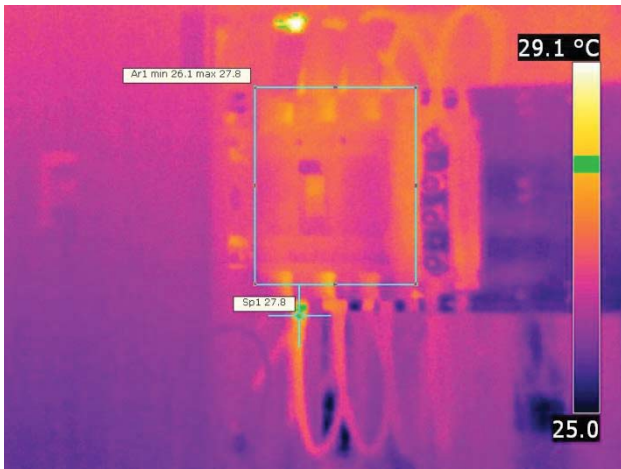
**Photo & Identification – ESS Main Supply Board Distribution (ESS MSBD L4)**

Location	Level 4, Front Reception
Equipment	ESS MSBD L4
Nom load	100%
Actual load	30%
Rating	(Low)
Recommendation	Monitor
Atmospheric Temperature	23.5°C
Area1 Min. Temperature	26.1°C
Area1 Max Temperature	27.8°C
Spot 1 Temperature	27.8°C

During 30% load, the above thermal scan picture indicates that the breakers temperature (26.1°C to 27.8°C) and Spot 1 – cable terminal temperature (27.8°C) are within the acceptable range.

Action: To monitor the temperature.

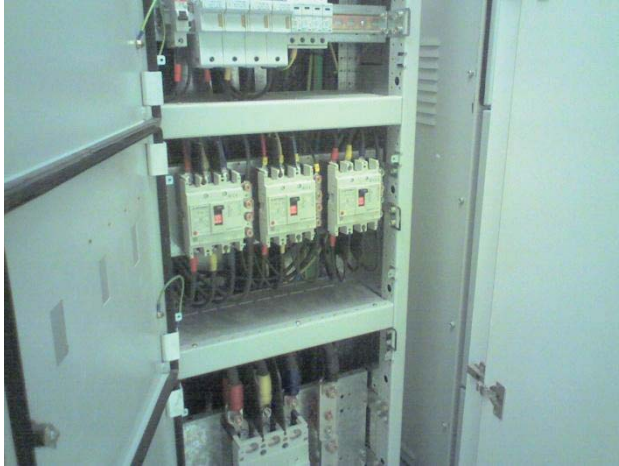
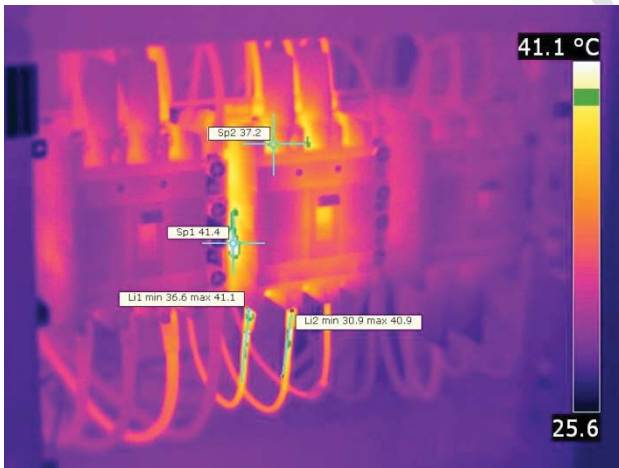
**Photo & Identification – Main Supply Board Distribution (MSBD)**

Location	Level 4, Front Reception
Equipment	MSBD
Nom load	100%
Actual load	60%
Rating	(Medium)
Recommendation	Monitor
Atmospheric Temperature	23.5°C
Line 1 Min. Temperature	36.6°C
Line 1 Max. Temperature	41.1°C
Line 2 Min. Temperature	30.9°C
Line 2 Max. Temperature	40.9°C
Spot 1 Temperature	41.4°C
Spot 2 Temperature	37.2°C

During 60% load, the above thermal scan picture indicates that the Spot 1- breaker temperature (41.4°C) and Spot 2 – cable terminal (37.2°C) are within the acceptable range.

Action: To monitor the temperature.

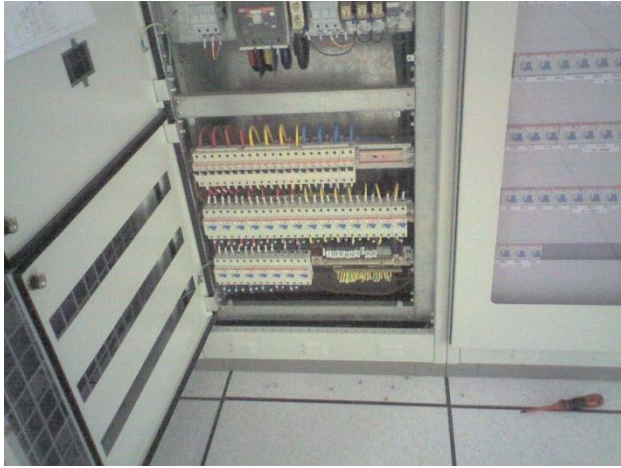
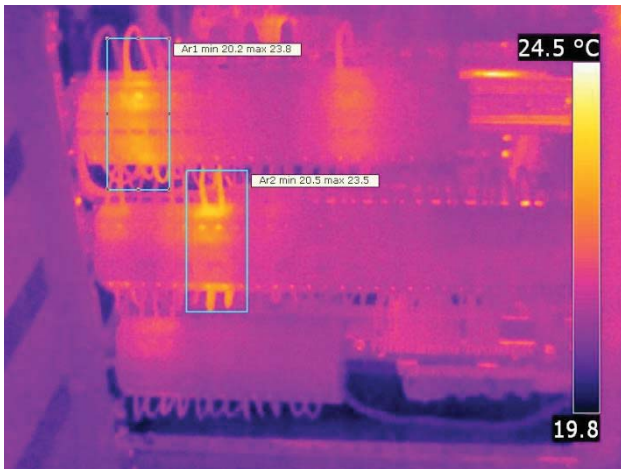
**Photo & Identification – Power Distribution Unit 1A**

Location	Level 4, Datacenter
Equipment	PDU 1A
Nom load	100%
Actual load	40%
Rating	(Low)
Recommendation	Monitor
Atmospheric Temperature	23.5°C
Area 1 Min. Temperature	20.2°C
Area 1 Max. Temperature	23.8°C
Area 2 Min. Temperature	20.5°C
Area 2 Max. Temperature	23.5°C

During 40% load, the above thermal scan picture indicates that some breakers has higher load than the others. Area 1 – breaker temperature (20.2°C to 23.8°C) and Area 2 – breaker temperature (20.5°C to 23.5°C). Both breakers temperature are within the nominal range of operating.

Action: To monitor the temperature and the load distribution.
